CITY OF WAUKON, IOWA

REPORT OF INDEPENDENT ROADWAY INSPECTION

2013 STREET IMPROVEMENT PROJECT

INDEPENDENT ROADWAY INSPECTION OF THE 2013 STREET IMPROVEMENT PROJECT – WAUKON, IOWA

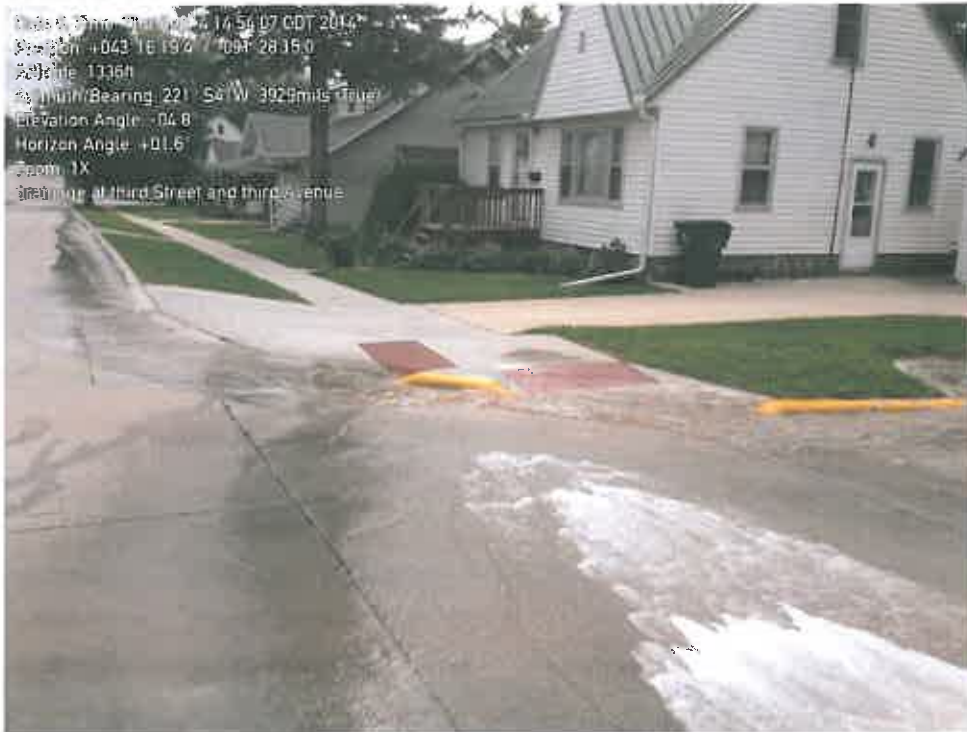
PHOTO #1

City staff opened up the fire hydrant at the intersection of 3rd Ave. and 3rd St. to see how changes in the sidewalk and driveway at the SW corner of this intersection would affect water flow. See Photo #1 below.

water going down the sidewalk, the driveway apron and ADA ramps were reconstructed to provide the equivalent of a 6" curb to attempt to keep water in the street rather than running down the sidewalk. See Photo #1 under "Field Reconnaissance". This reconstruction of the ADA ramps appears to have worked as well based on the observation from the fire hydrant flooding discussed in the "Field Reconnaissance" section.

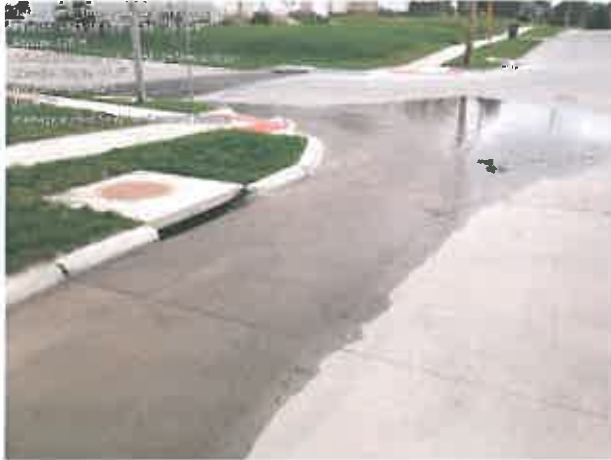
PHOTO #2

The water was also directed down the east gutter line and flowed to the NE corner of the intersection of 2nd Ave. and 3rd St. so that we could see how the intakes at this location functioned. See Photo #2 & #3 on the next page.

Findings: Much of the water runs past the intakes and ponds in this area. See Photos #1 and #2 under "Field Reconnaissance".

Recommendations: The boxouts (pavement area in front of and to the sides of the intake) should be reconstructed to create more of a throat to channel water into the intake. Along with reconstructing the boxouts, some grinding of the pavement should be done from the lowest point of the ponding area to the edge of the reconstructed boxout.

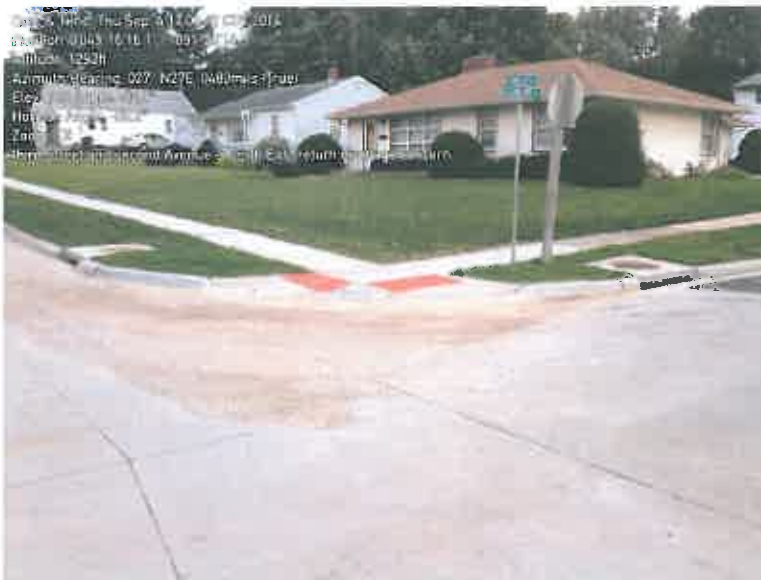
PHOTO #4

Concern #1: Intakes are not efficient in collecting water at the NE corner of 2nd Ave. NE and 3rd St. NE and water ponds in the street.

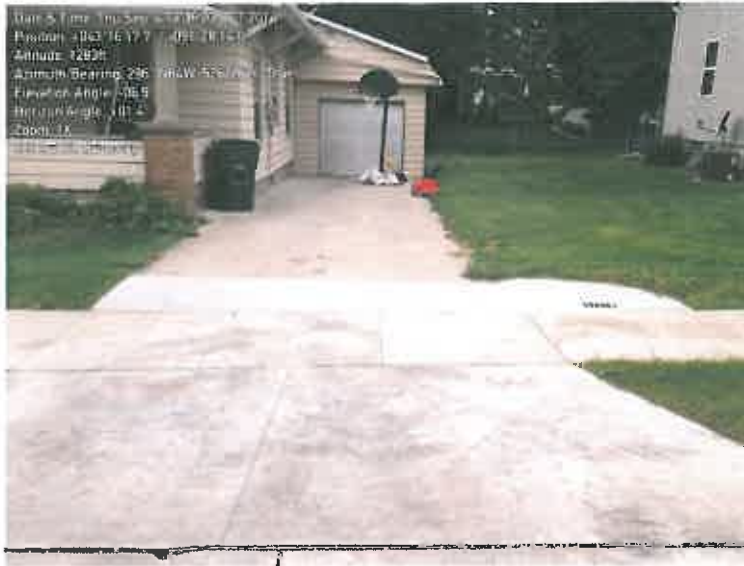
PHOTO #5

Concern #2: Water runs down the driveway at 206 3rd St. NE, enters the garage and gets into the basement.

Findings: It is claimed that water is leaving the roadway and draining onto and down the west sidewalk and then down this driveway and getting into the garage and into the basement. This problem was occurring during construction and since the time of the observation of the water getting into the garage and basement the hump in the driveway as seen at the back of the sidewalk was constructed and the intake seen on the north side of the driveway was constructed. It appears that this “fix” may be sufficient to keep water from the street right-of-way from continuing to go down the driveway.

However, it is to be noted that the original driveway had always been draining towards the garage so there may always be a certain amount of water getting into the garage.

Recommendation: No further action is recommended at this time. However, it is recommended that this particular area be observed during future rain events to see if the already constructed fixes are working properly. If not, further action may be necessary and can be considered at that time.

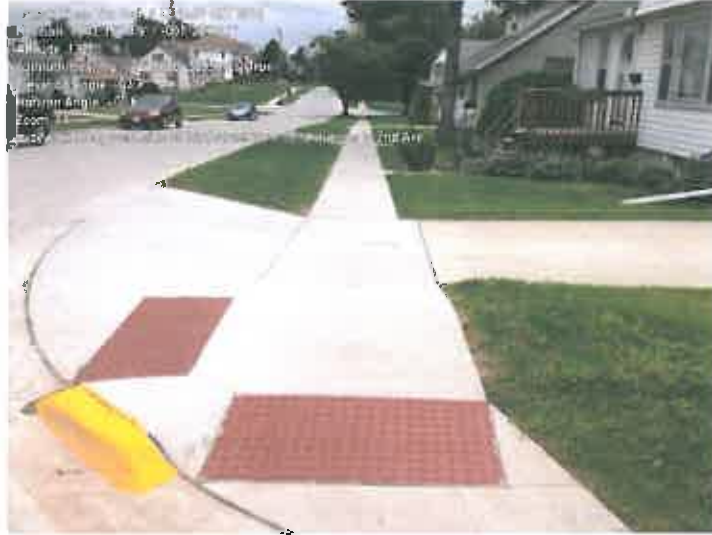
PHOTO #6

Concern #3: Water leaves the roadway at the SW corner of the intersection of 3rd Ave. NE and 3rd St. NE and flows down the west sidewalk.

Findings: It is claimed that water is coming across the intersection from the north and going down the west sidewalk rather than staying in the street. This is causing most of the problems experienced in Concern (2) on the previous page. Again this problem occurred during construction and since the time of the rain event and

Recommendation: No further action is recommended at this time. However, it is recommended this area be observed during future rain events and if water is observed to leave the street and run down the sidewalk, the reconstruction of the west gutter line or possibly other corrective actions be performed at that time.

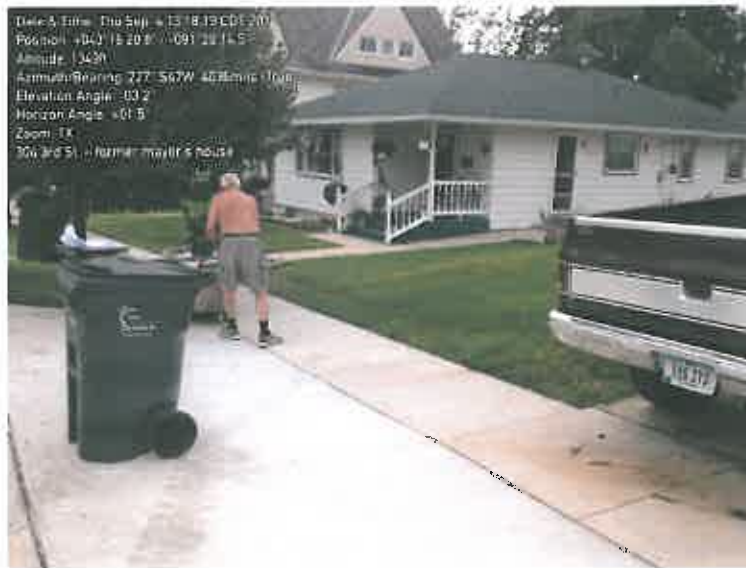
PHOTO #7

Concern #4: Water leaves the roadway and comes onto property at 304 3rd St. NE and seeps into the basement.

Findings: It is claimed that water is coming off of the street and down the driveway located north of House #304 then flows down the sidewalk and onto property at #304 and is reportedly seeping into the basement.

Fehr Graham has indicated they were considering reconstructing the driveway apron for house #306 to essentially create a 6" curb to prevent water from leaving the street.

Recommendations: Veenstra & Kimm, Inc. agrees with performing this work although it will create a less than desirable driving situation along the southern most portion of the driveway. However, since this is a low speed situation it is recognized this should be manageable.

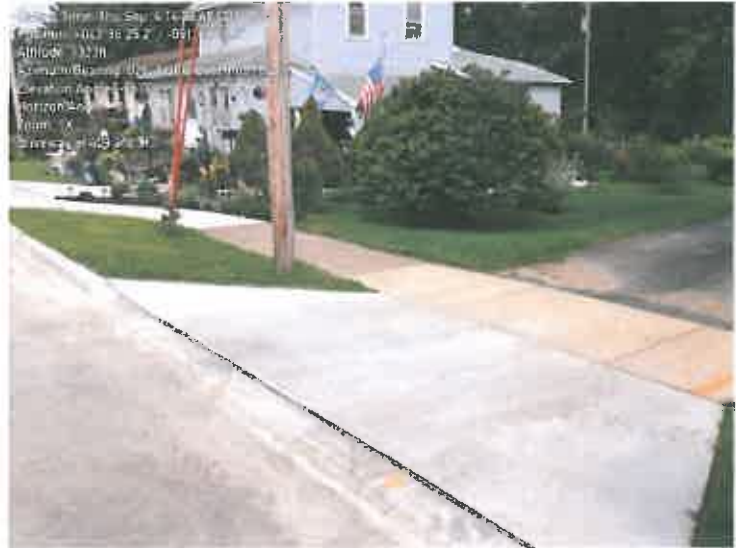
PHOTO #8

Concern #5: Water leaves the roadway and flows down the driveway and into the garage at 411 3rd St. NE.

Findings: It is claimed that after construction, water is now flowing down the driveway and into the garage to house #411. After visiting this location and reviewing the plans and cross-sections in this area, it appears that the street right-of-way had drained towards house #411 prior to construction and continues to drain this way after construction. An intake has

Recommendations: No further action is recommended.

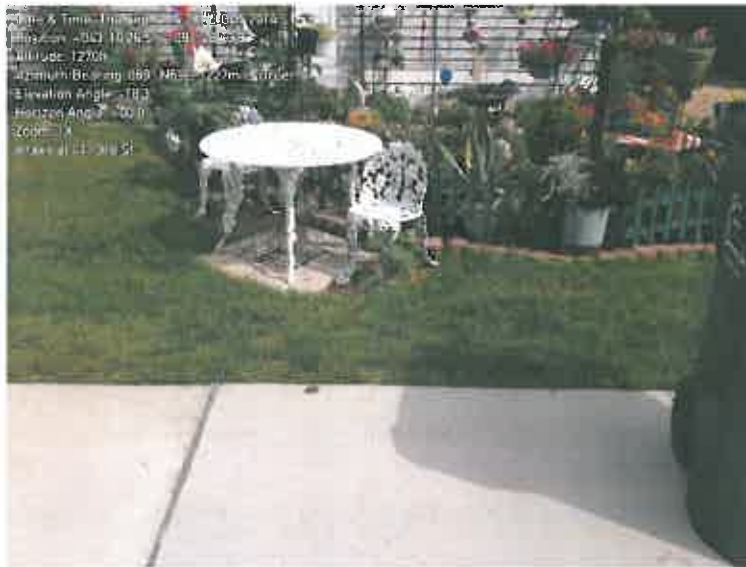
PHOTO #9

been constructed in what appears to be a low point in the front yard of house #411 just to the north of the driveway. See Photo #9.

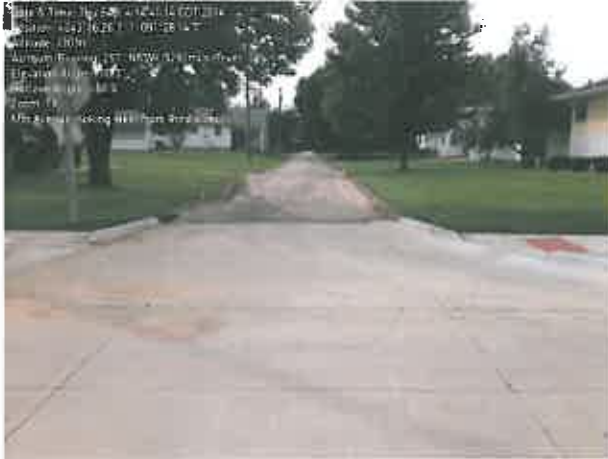
PHOTO #10

Concern #6: Water is not draining properly at the intersection of 5th Ave. NE and 3rd St. NE and the road was built higher than designed and is now causing water to seep into the basement at 209 5th Ave. NE.

Findings: The intake at the SW corner of the intersection of 5th Ave. and 3rd St. was removed and not replaced. It is claimed that water is now getting into the basement of house #209 5th Ave. and water now stands in the gutters of 5th Ave. because the elevation of the road was raised and the intake was not replaced.

Recommendations: It is Veenstra & Kimm, Inc.'s recommendation that a pair of intakes be installed, one at the SW corner and one at the NW corner of this intersection, and tied into the subdrain tiles currently going across the road to the intake on the east side of the intersection.

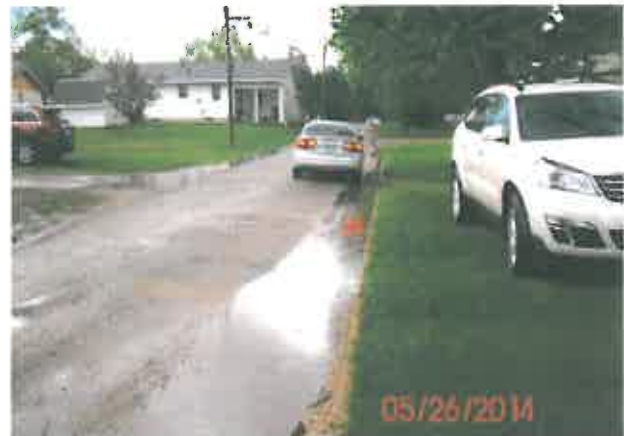
PHOTO #11

Regarding water along the edges of the roadway as shown in Photo #11 on the previous page, it appears that the water in the south gutter line is ponding due to conditions that existed prior to construction outside the project area and is not caused due to construction. It is Veenstra & Kimm, Inc.'s opinion that the water shown in the north gutter line is simply spreading and not ponding due to flatter areas in the pavement.

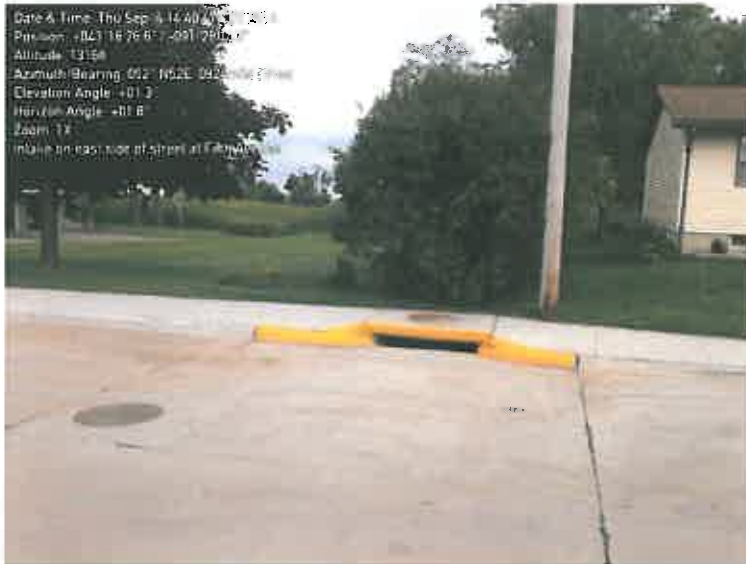
PHOTO #12

It was determined that the road was not raised in this area other than backfilling behind the new curb that was constructed on the west side of 3rd St. going south of this intersection where there was no curb before. In fact this intersection was constructed slightly lower than before to allow water to drain across the intersection to the new intersection on the east side. See Photo #12.

It is Veenstra & Kimm, Inc.'s opinion that the project did not cause water to get into the basement of house #209 5th Ave.

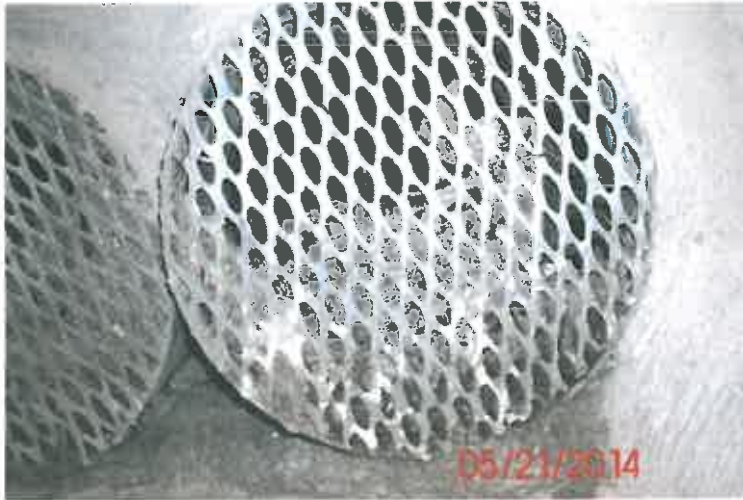
PHOTO #13

Concern #7: Debris is getting into the newly constructed subdrain system and is plugging at the subdrain outlets.

Findings: The above photo was provided to Veenstra & Kimm, Inc. by one of the property owners. As you will note, there is some debris behind the rodent guard of one of the subdrain tile.

Recommendations: It is recommended this be cleaned out and all subdrain lines connected to a surface drain be checked. If subdrains that has a surface intake connected to it and continues to be blocked with debris, it is recommended that the rodent guard be removed.

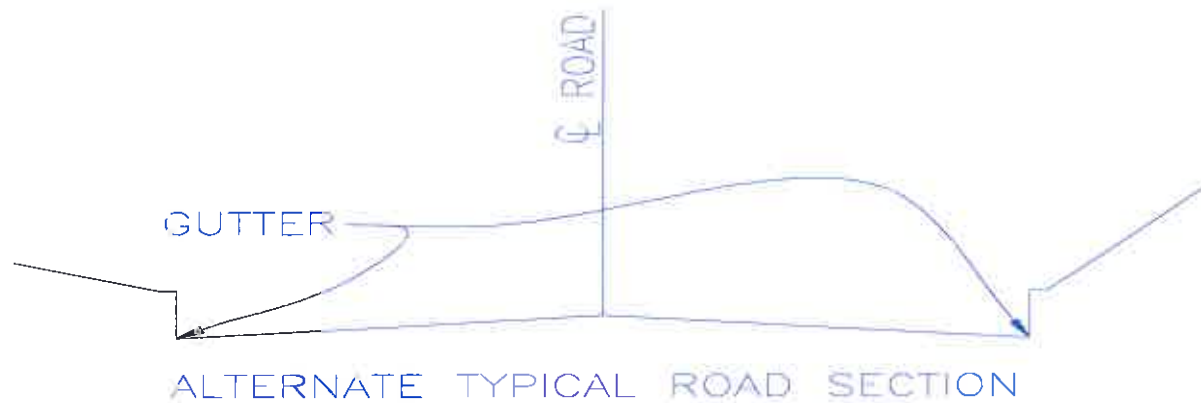
One alternate design concept Veenstra & Kimm, Inc. considered was utilizing the actual designed roadway cross-section as-is, but simply lowering the street where necessary so all of the road ROW would drain to the street. This is your typical and most desirable design concept, when/where possible. Lowering the street is an alternate design that several citizens and council members believe could have and should have been used to avoid the drainage concerns. See the "ALTERNATE TYPICAL ROAD SECTION" below.

However, when considering the alternate design concept (i.e. lowering the street), other undesirable issues likely would have resulted. These undesirable issues consist of several driveways on the east side would have been excessively steep; additional trees would have had to be removed; cover over the existing water main may have been reduced; and in some locations retaining walls likely would need to have been constructed adjacent to the ROW line.

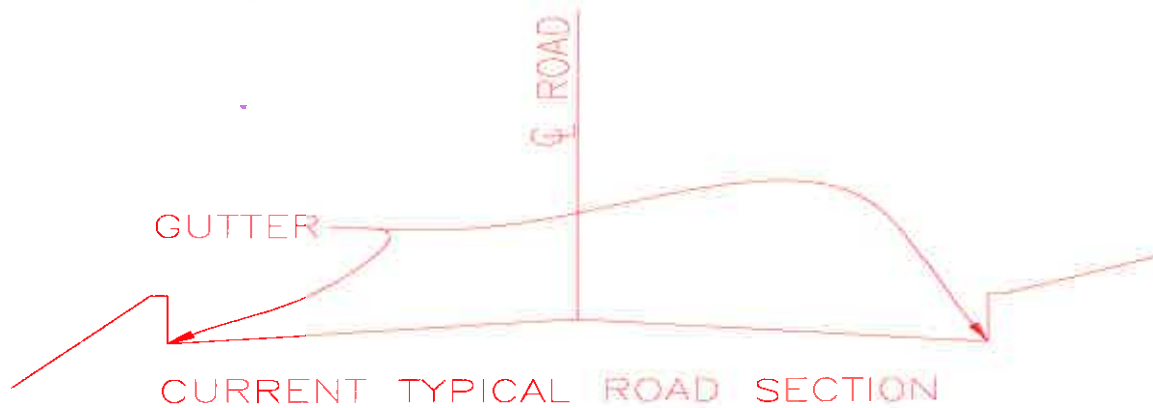
This project as designed and as constructed has the following as the Typical Road Section. Note the slopes behind the curb and gutter:

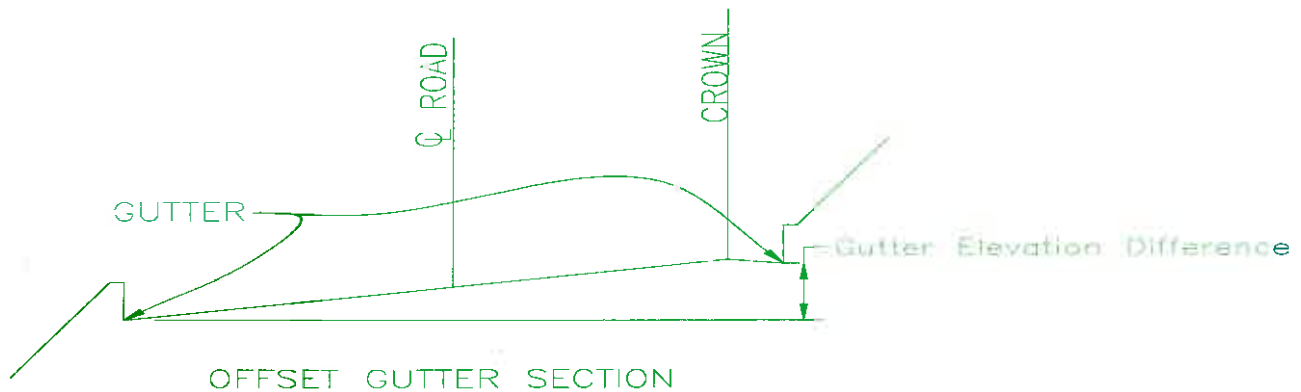
The second design concept Veenstra & Kimm, Inc. considered was the idea of having offset gutter lines, much as the original street had. See the "OFFSET GUTTER SECTION" below. With this concept, for most of this project the east gutter line would have been higher than the west gutter line. Typically the crown of the road would be at the centerline of the road but for this concept it would need to be shifted to the higher side of the road to allow for an adequate gutter elevation difference from one side of the road to the other so that you could avoid excessively steep cross-slopes as the existing roadway appeared to have before on the southbound lane.

Again, as with the previous alternate, when considering this alternate other undesirable issues arose. These undesirable issues consist of how the road would ride; potential for drainage to sheet across the roadway causing ice issues in the winter; the carrying capacity of the higher gutter area is greatly reduced; and transitioning issues between this section and other sections or at intersections. In addition, some cutting or lowering of the existing grade would be required on the west side in some areas, thus reducing cover over the existing water main.
